TECHNICAL CUSTOMER SERVICE

Sensor locates danger points with maximum precision

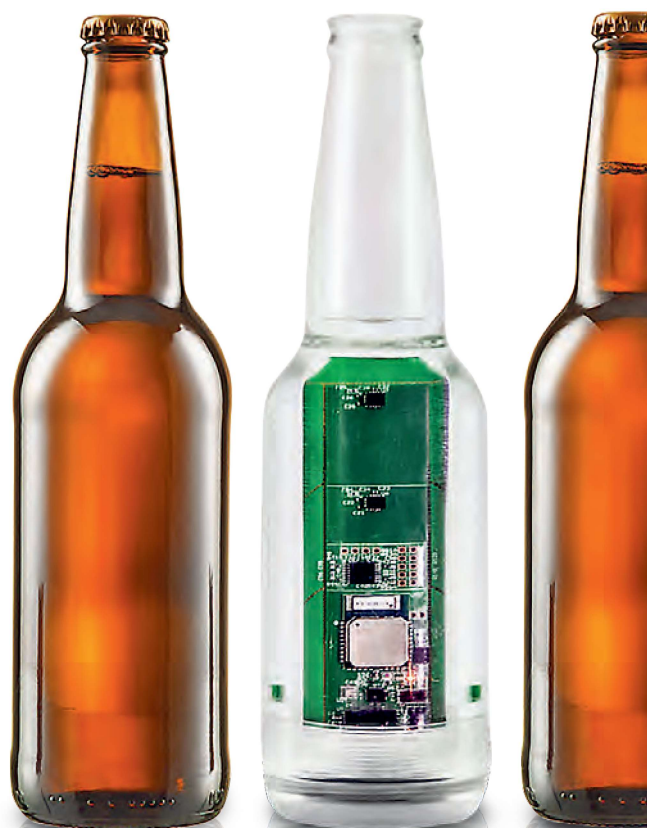
To shed light on the matter, our customer service team used the new addition to our toolbox for the first time: the ShockQC in-line sensor from Masitek of Canada. It measures the forces and loads acting on a glass

container with maximum precision. As part of our service, we produced an exact replica of the glass container to be tested for our customer: in this case, a 390-ml European jar.

This dummy made of highly resilient plastic was fitted with a ShockQC sensor calibrated by the manufacturer. It then began its journey along the filling line together with a batch of other jars. A total of four tests were performed, each at different belt speeds. The dummy and sensor passed through the entire line, starting with unpacking of the jars all the way to the final conveyor belt that carries the jars away in their finished

cartons. The measured datasets were transmitted no less than 100,000 times per second to a tablet PC for visualisation on an easy-to-understand dashboard.
